**FINAL**  
**EAST TRENCHES PLUME PROJECT**

**CLOSEOUT REPORT**  
**FISCAL YEAR 1999**

Rocky Flats Environmental Technology Site

February 17, 2000

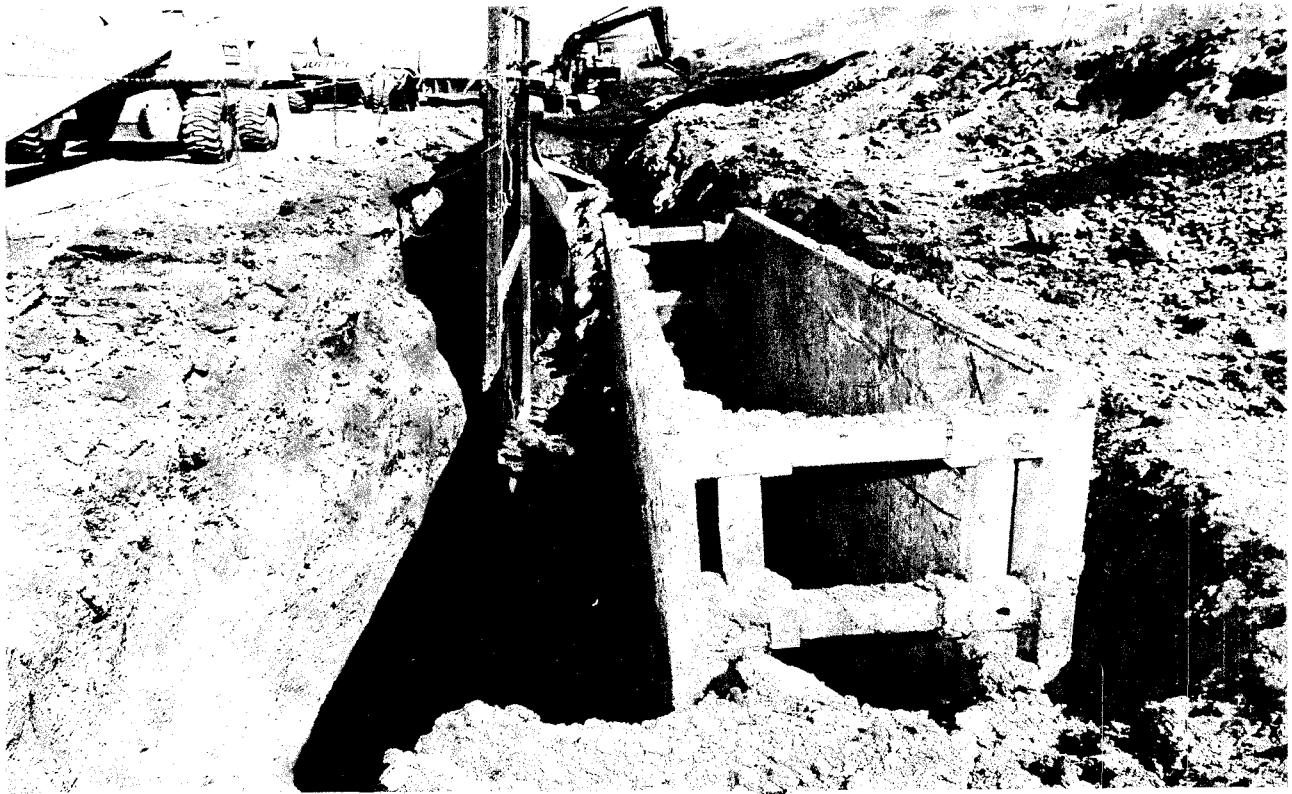
## Installation of Panels at East Trenches

The groundwater collection system extends approximately 1,200 feet in an east-west direction (Figure 1) and captures the majority of the contaminated groundwater plume. To install the collection system, an excavation was dug at a variable depth of approximately 16 to 26 feet below ground surface, at least 6 inches, and on average, 3 feet into claystone. An impermeable barrier was installed that consists of 80-mil high-density polyethylene (HDPE) panels fitted with an interlocking strip on each side. A hydrophilic cord was threaded through the entire length of the interlock. This cord swells when wet, further sealing the panels together. These panels are 15 feet wide and of a variable height depending on the installation depth.

Significant failure of the excavation occurred during installation of the collection system. This failure was due in part to well above average precipitation during installation of the collection system, which saturated and destabilized the excavation, and to a previously unidentified fault zone in the collection system area. Failure of the excavation resulted in damage and removal of several barrier panels. When continued installation of the collection system was not possible under existing conditions, a sand trench was installed along the planned location of the western half of the collection trench to drain the area. After the sand trench was completed, the barrier panels were installed starting at the western end of the collection trench. Solid steel plates were used to support the panels during installation instead of the previously used hollow frames. These solid plates were additionally braced by I-beams and, along with a modified trench box, limited excavation collapse.

Where the two portions of the collection trench met, it was not possible to interlock the panels due to the conditions. Therefore, a panel from the western leg of the collection trench was installed that overlaps the eastern leg of the collection trench by approximately 4 feet. The area between the two panels was filled with bentonite. The area behind the overlap in the panels was filled with bentonite to the top of the panels. In all, 5.5 supersacks of bentonite, each containing approximately 3,500 pounds, were utilized to seal the area where the two panels overlap.

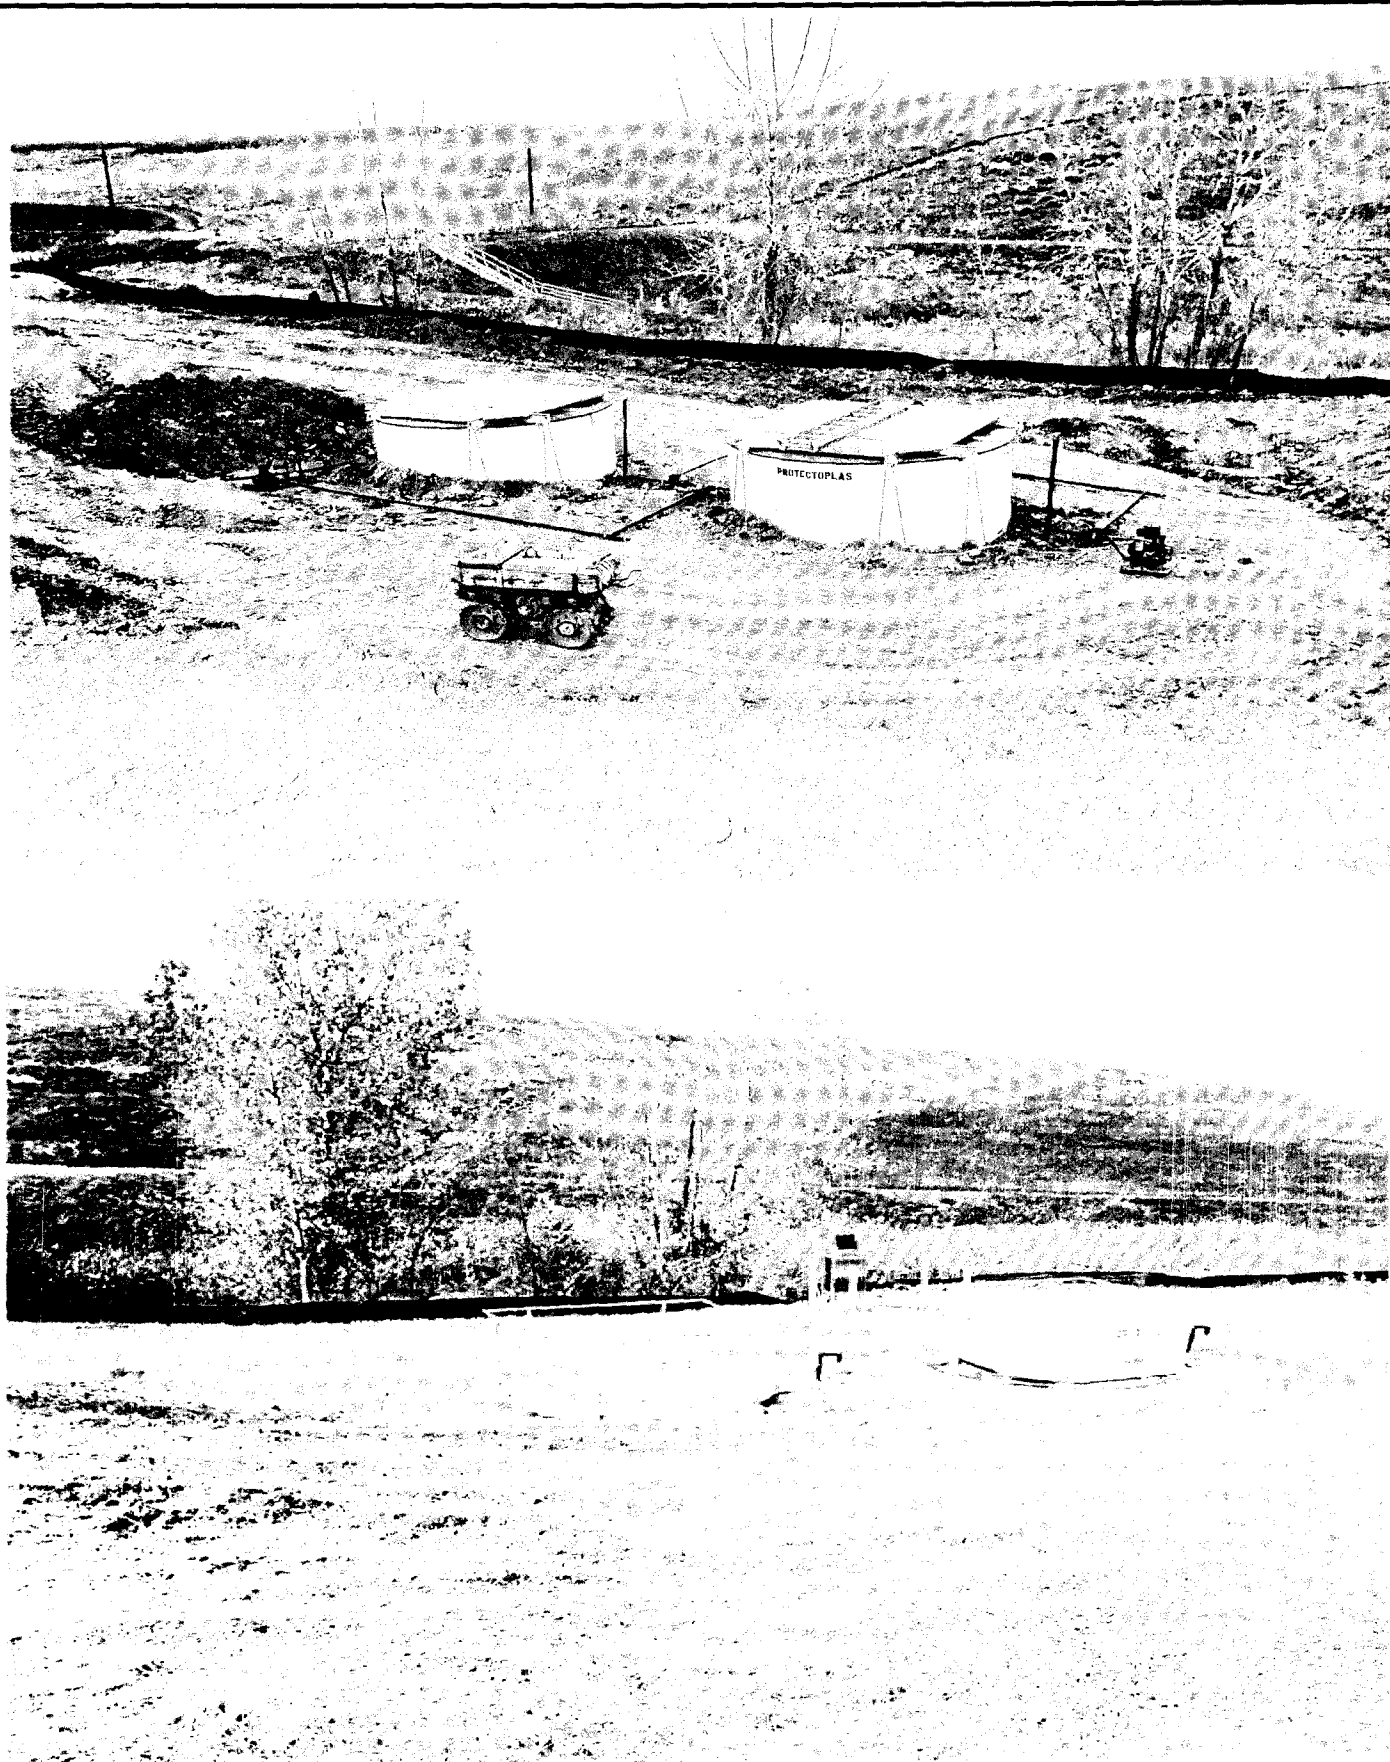
## East Trenches Treatment Cells

The treatment system consists of two high-density polyethylene tanks containing reactive iron, which degrades the dissolved VOCs in the groundwater. The system utilizes iron to induce conditions where hydrogen is substituted for chlorine in the chlorinated VOCs. The end products of the process are completely dehalogenated hydrocarbons and non-toxic salts. The treatment cells are approximately 12 feet in diameter and 13 feet tall. Groundwater enters the cells at the top and percolates through the 6.5 feet of iron. There is one foot of granular material on the bottom of each treatment cell to disperse the

groundwater. The upper foot of each cell is a 50/50 mixture of iron and pea gravel to simplify mechanical break-up of the expected crust formation.
